## MEMORANDUM

**From:** Brian Kuchar, RLA, P.E.

**Date:** October 7, 2022

**Re:** ***Getchell Trail Summary of Findings and Recommendations***

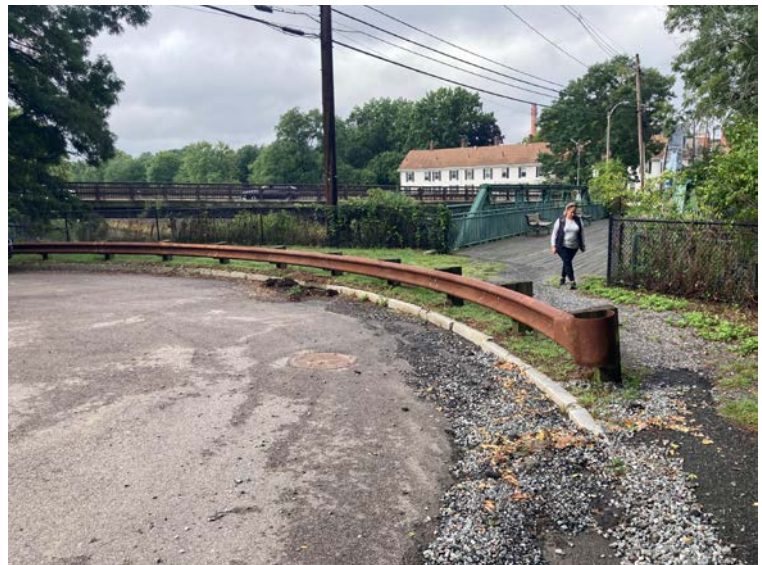
**Recommendation 1:**

This section of trail begins at the Danforth trailhead and the Old Danforth Street pedestrian bridge and is intended to be ADA accessible. The length of trail is comprised predominantly of boardwalk through existing wetlands with small sections of earthen path to break up the boardwalk. This section ends at a small overlook and memorial bench with an awkward 90 degree turn over a boardwalk crossing to connect to the Mary E. Stapleton Elementary School stairs. The understory is fairly healthy and low, which provides nice sight lines along the trail as well as select views to the river. There is a Japanese knotweed (*Fallopia japonica*) issue within the wetlands at the beginning of the boardwalk section to the north that should be addressed.

- Create parking spaces at the end of Hillside Street.
- Improve drainage and provide additional stormwater treatment along the edge of the cul-de-sac.
- Provide an ADA accessible path to the pedestrian bridge and connection to the Getchell trailhead.

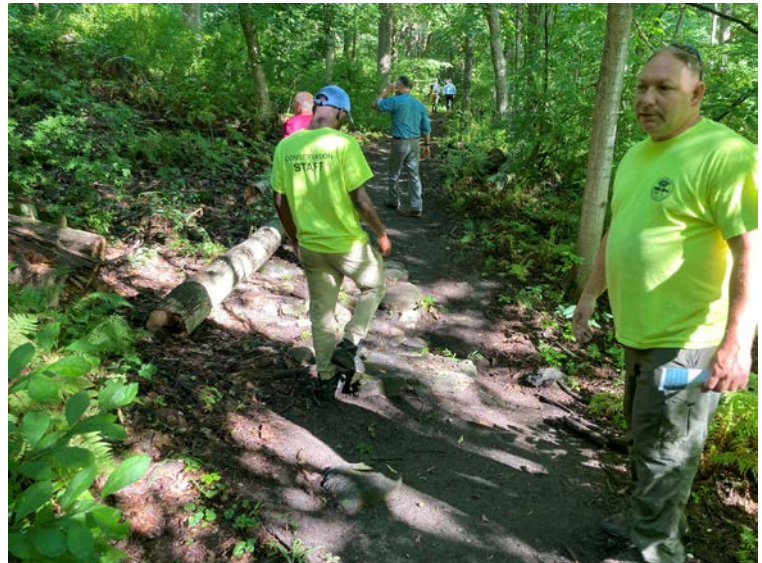
**Recommendation 1:**

This section of trail begins at the connection to the Mary E. Stapleton Elementary School and ends at the Hultman Aqueduct and is not intended to be ADA accessible. The trail is comprised of an earthen path and is located outside of the wetlands. Overall the woodland along this section of the trail is healthy with minimal understory, limited invasives and good sight lines. There are three stormwater crossings (overland flow) that cross the path, show evidence of erosion and compromise the stability of the trail surface.

- Provide a limited boardwalk crossing/bog bridge at the three stormwater crossings to create safer access and footing along the path. The crossings have been added to the survey plans.
- Repair trail surfaces where erosion has occurred or solid footing has been compromised.

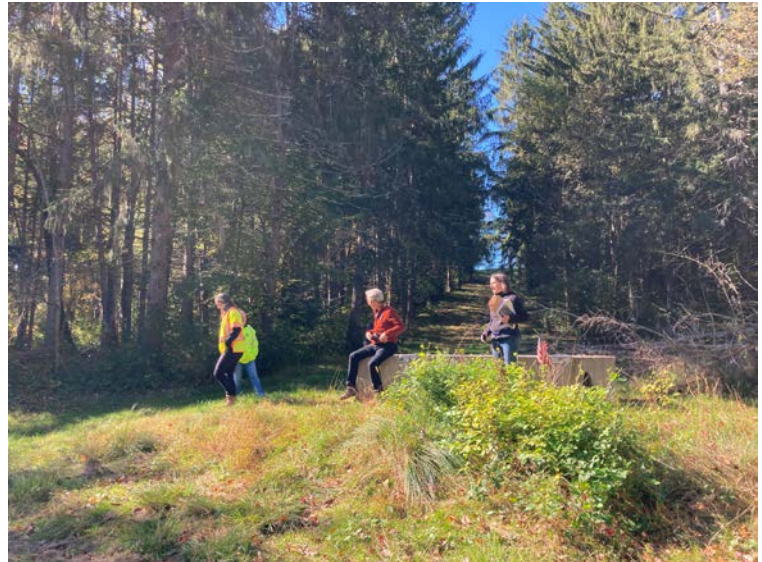
#### ***Recommendation 1:***

This section of trail begins at the Hultman Aqueduct, ends at the connection to the Cameron Middle School and is not intended to be ADA accessible. The trail is comprised of earthen paths and sections of limited boardwalks to cross over stormwater crossing/drainage ditches. Based upon the GIS data, the trail appears to be located both within and outside of the wetlands. Upon crossing the aqueduct a noticeable change in the vegetation was observed. After walking thru a pine grove (planted as part of the aqueduct project) the understory vegetation is dense and dominated by green briar (*Smilax rotundifolia*) and poison ivy (*Toxicodendron radicans*) in sections. Invasives plant species are also present, including bittersweet (*Celastrus orbiculatus*) and multiflora rose (*Rosa multiflora*) to name a few. Overall the sight lines thru this section are limited. Based upon discussions with the Conservation maintenance staff, this section of trail requires the most maintenance, including regularly cutting back the brush, with a brush hog, to maintain a safe trail width.

- Provide trail wayfinding signage at the Hultman Aqueduct.

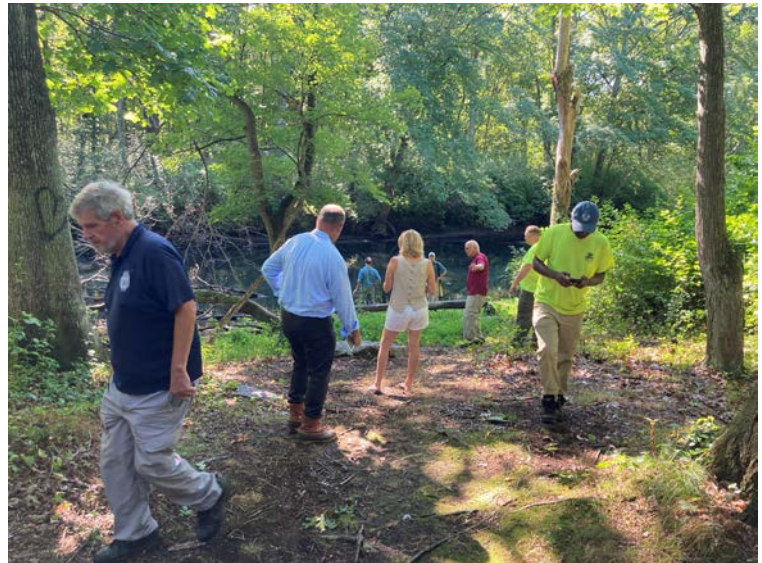
#### **Recommendation 1:**

This section of trail begins at the connection to the Cameron Middle School, ends at the Little Farm Road trailhead. A portion of the trail from the existing overlook clearing to the trailhead is intended to be ADA accessible. The trail is relatively flat through this section and currently comprised of earthen path. The trail is located outside of the wetlands but within the Riverfront area and flood zone. A parking area with 7 spaces along with a canoe/kayak launch are provided at the trailhead. The vegetative understory through this section thins out and opens up as the trail gets closer to the trailhead and parking area. Overall the sight lines thru this section are good.

- Create a formal ADA accessible area at the existing overlook clearing.
- A deck platform with built in benches was discussed.
- This would be the destination point for an ADA trail from the parking area.

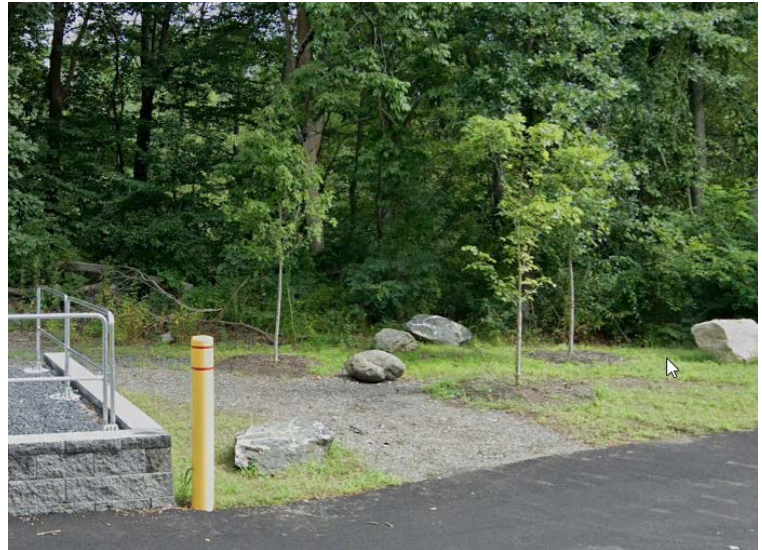
**Recommendation 1:**

This short section of trail begins at the Little Farm Road trailhead, ends at the Weston Aqueduct and is not currently intended to be ADA accessible. The trail runs through a narrow corridor close to private property and along edge of the river at the top of the river bank and has a significant change in elevation as it approaches the aqueduct. The trail is located outside of the wetlands but within the Riverfront Area and flood zone. There is one stormwater crossing over the trail and the vegetative understory through this section appears to be fairly healthy with good site lines.

- Add trail wayfinding signage at the trail heading north to the aqueduct.

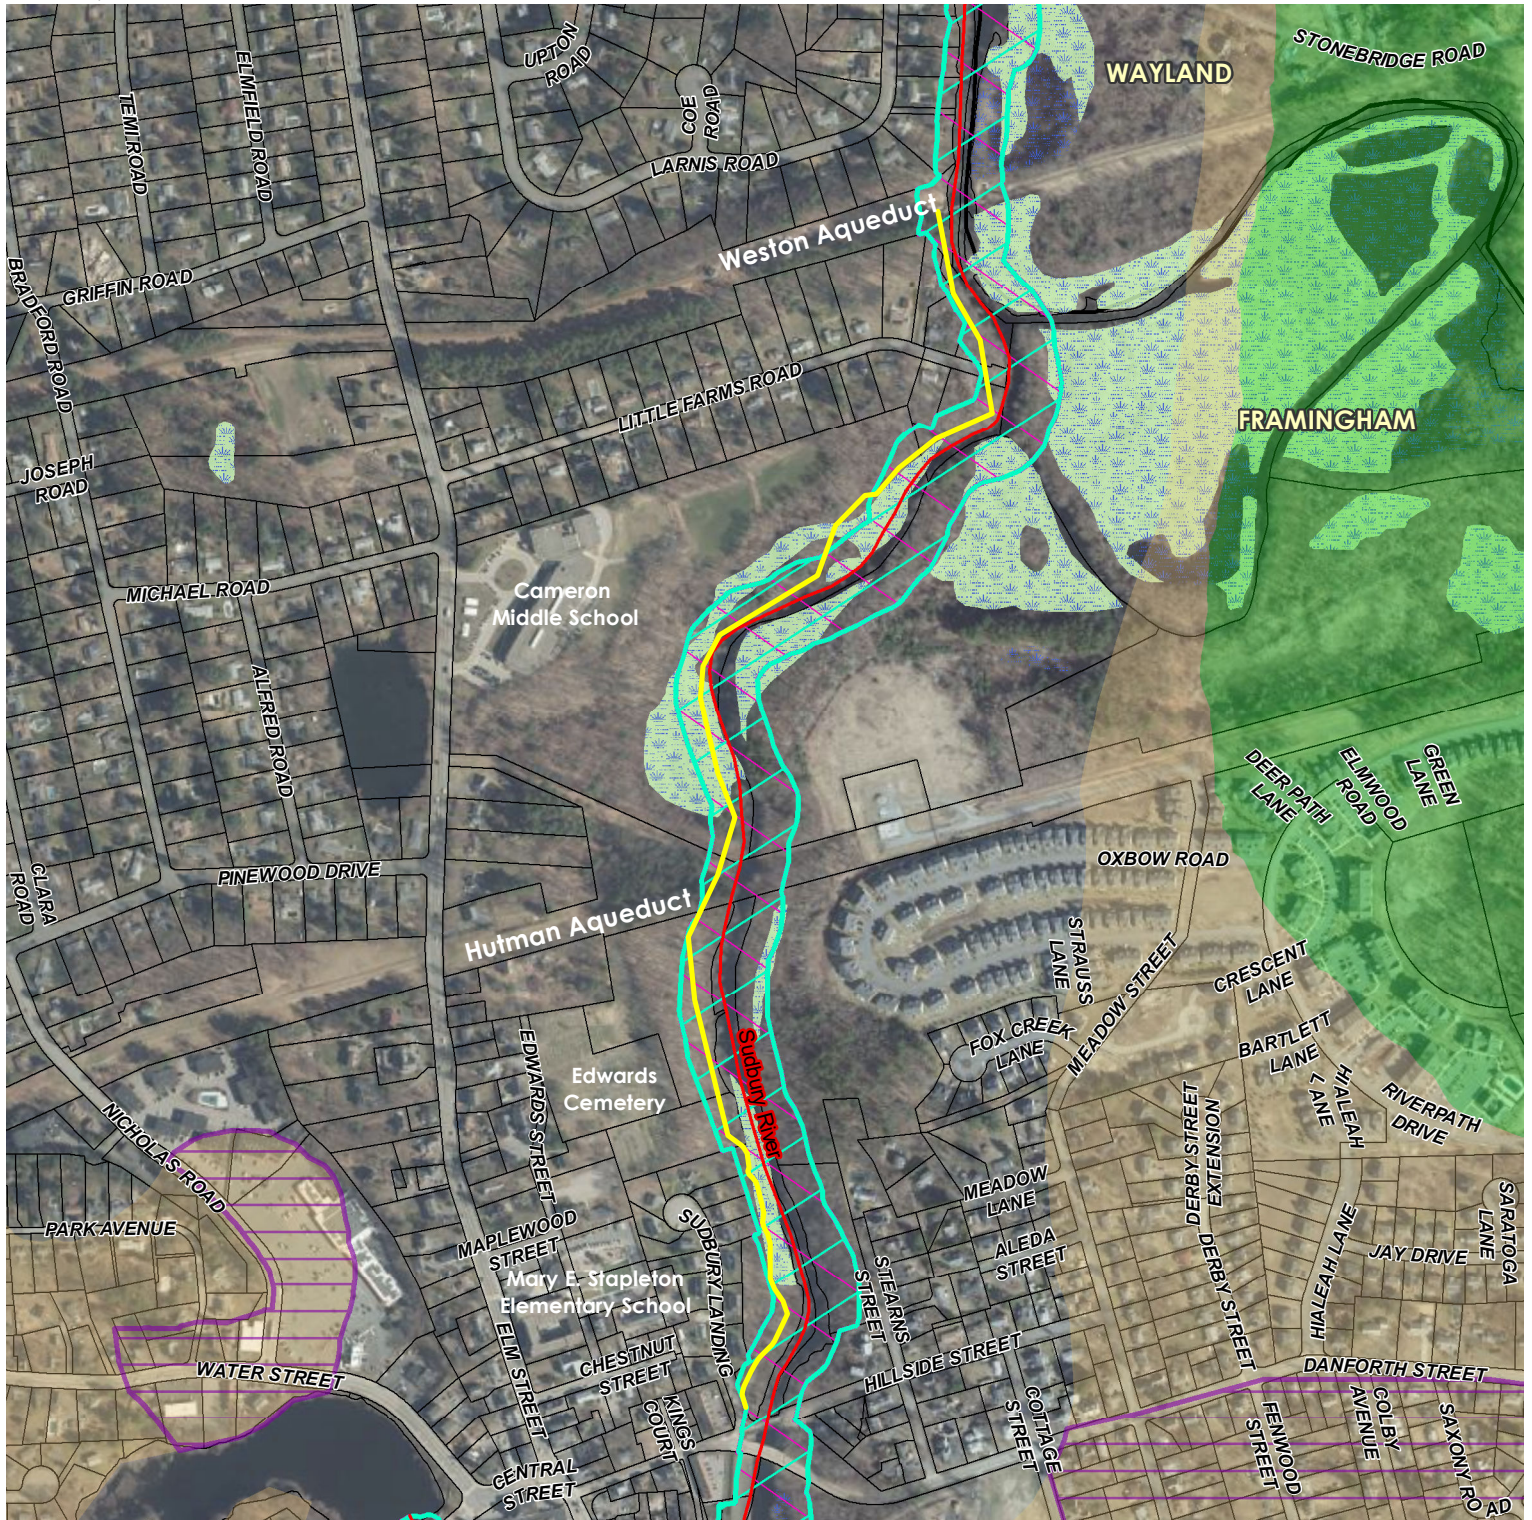
**Figure 2**  
Environmental Constraints.

- Getchell Trail
- NHPSP Priority Habitats of Rare Species
- NHPSP Estimated Habitats of Rare Wildlife
- Medium Yield Non Potential Drinking Water Source Area

- 5 - Impaired - TMDL required
- High Yield
- Medium Yield Aquifer
- Marsh/Bog
- Wooded marsh

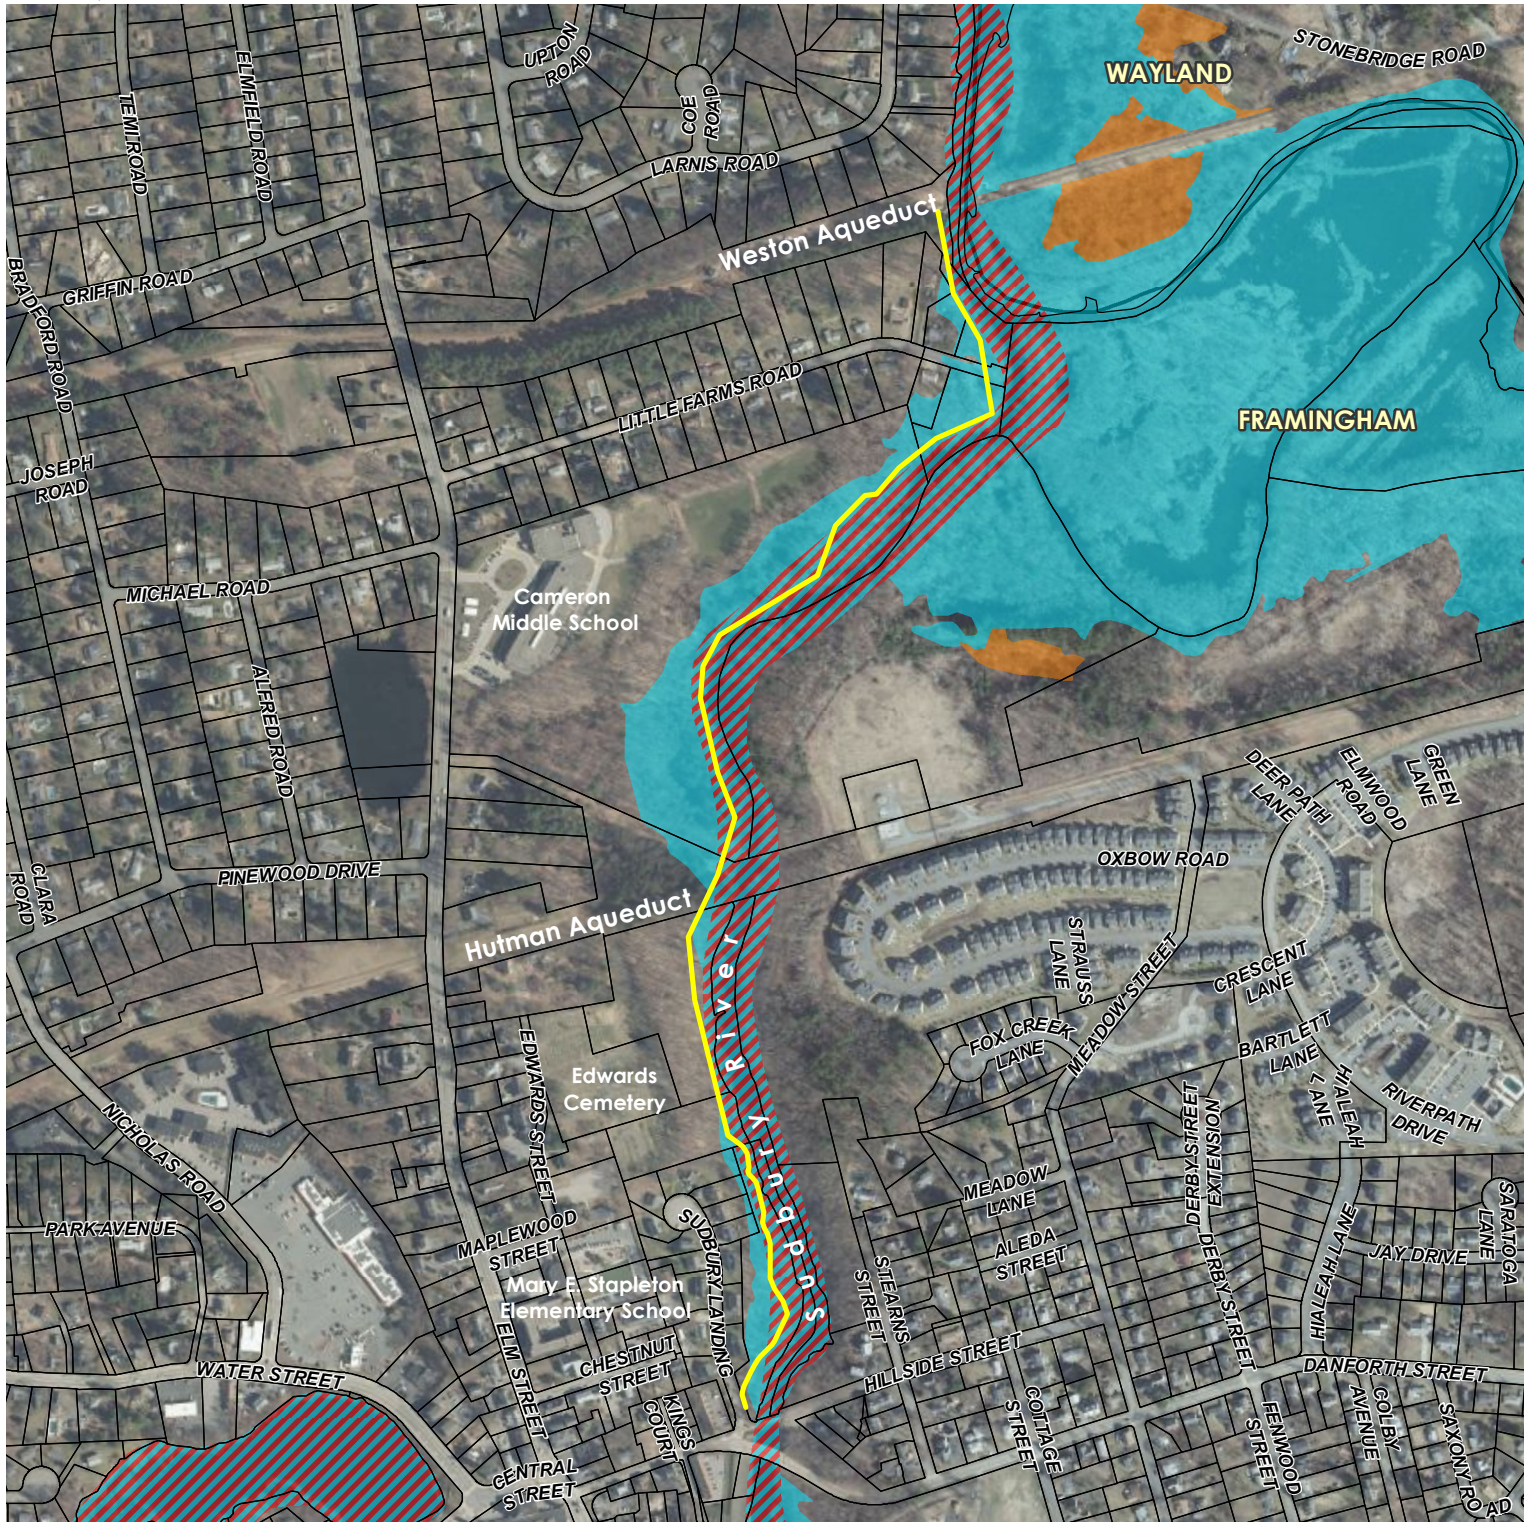
**Figure 4**  
FEMA National Flood Hazard Layer.

■ AE: 1% Annual Chance of Flooding, with BFE

▨ AE: Regulatory Floodway

■ X: 0.2% Annual Chance of Flooding
